Problems with Falcon Stainless Steel Exhaust Systems

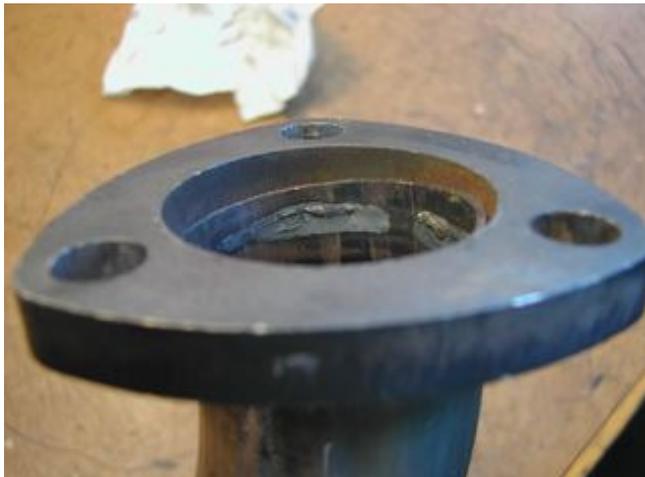
The center to center distance between the flange holes is 2.365. The center to center distance on the exhaust manifold studs is 2.493.

That makes the Falcon holes 1/8" too close together.

So what did the brilliant engineers at Falcon do? They made the holes bigger. (.470) But not quite big enough, as I had to file about .030 on each hole to allow the flange to go over the manifold studs which are .312 Dia.

#Photo 1. Flange is welded on exhaust pipe crooked. The forward pipe from the manifold to the muffler has the flange welded on crooked, swinging the pipe inward. It jams against the rear pipe and won't allow the flange to lay flat against the manifold. I only found this out after having to file the flange holes to get it on the manifold.

Remedy: Heat pipe just below the flange and pull it out bit by bit. Also see photos 4 and 5.

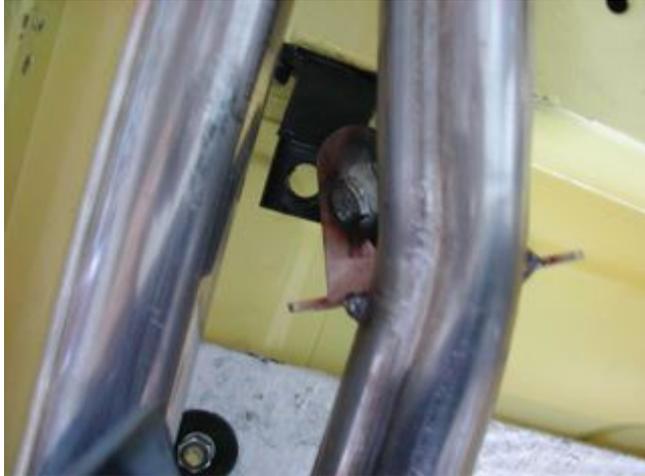
Photo 2 Bracket stud is about 1" off center. The Falcon hanger at the rear of the muffler/front of the tail pipes is off-center with a bolt welded in. My old pipes had the bracket hole centered between the pipes, I can't move the pipes over as the muffler hits the rocker and the pipes won't lay in the relief in the outrigger.

Remedy: Saw off Falcon bracket. Make up a bracket to clamp both pipes with a stud on center. See also photos 3, 8, 9 and 10.

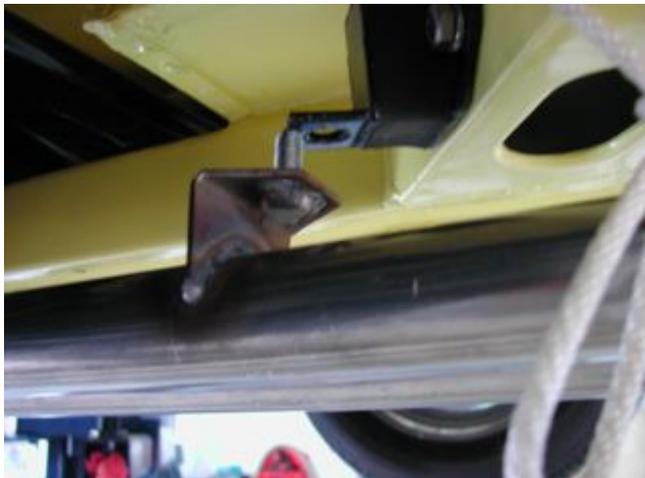
Photo 3 and about 1/2" too far aft.

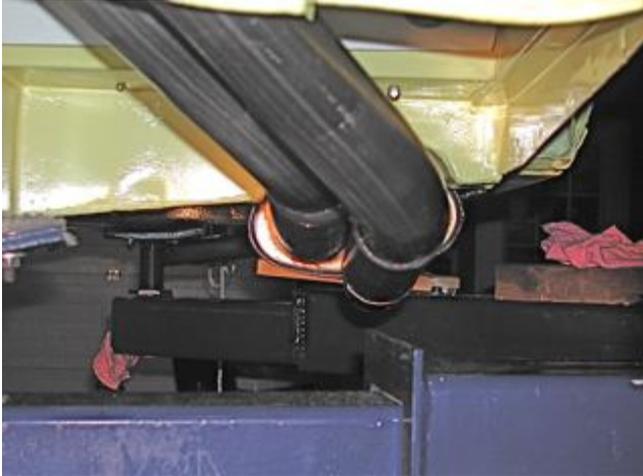
Photo 4 Pipe interference

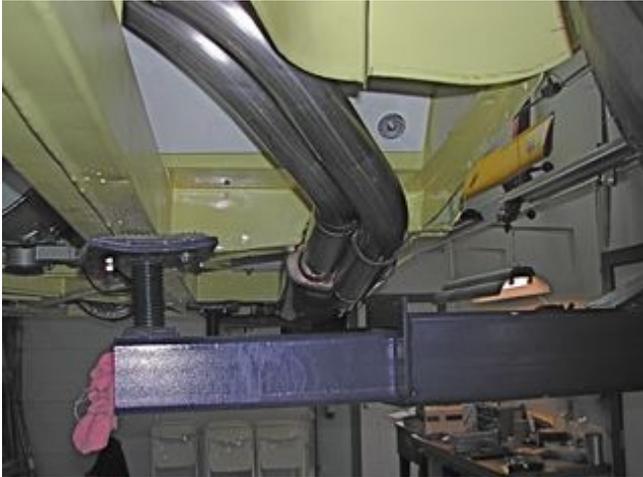
Photo 5 pipe interference

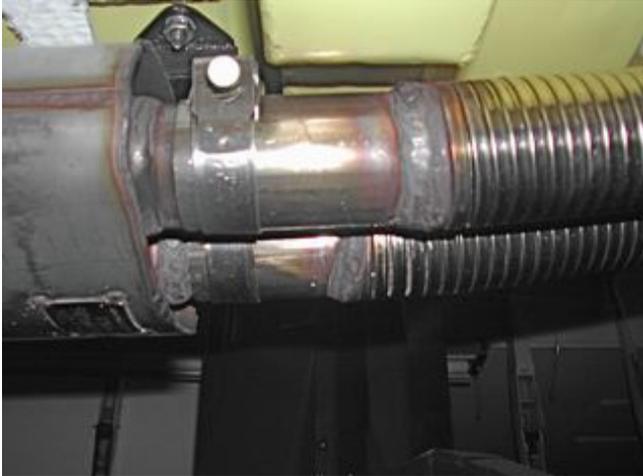
Photo 6. About 1" cut off of outside pipe. The front pipe is about 1" too long at rear of the flex area. This means the part that slips on the muffler will have to be cut off.

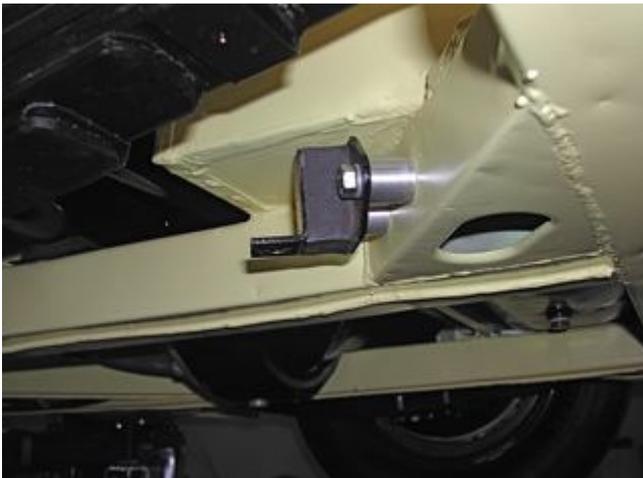
Photo 7 Rear hanger W/ 1/2" spacers. The angle clip at the extreme rear is welded on to the tail pipes about 1/2" too far forward.

Remedy: Make two 1/2" spacers to put behind the mounting bracket.
